TOPIC: HYDRO BELT TENSION SPRING

AFFECTED: HW32, HW36 & HW48

Serial no. 197-227, 2166-2385 & 1783-2153 (respectively)

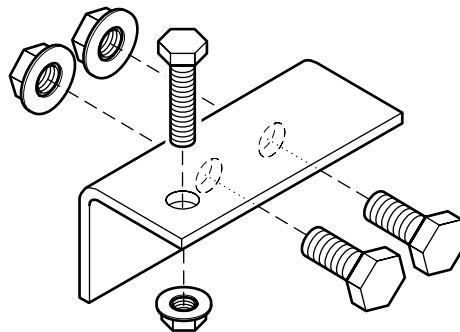
Field reports have indicated the belt tension spring (20807) for the transmission drive belt is breaking due to the anchoring method. To rectify this problem, a HW Spring Anchor Assembly (44800) is available through the Parts Department.

1. Park machine on a flat, level surface and apply parking brake.
2. Remove rear engine deck screen and set aside.
3. Remove and discard the extension spring (20807) that tensions the hydro belt idler arm. (This is the spring that is hooked through the side of the engine deck.)
4. Assemble bracket, 5/16-18 x 1-1/4" bolt and 5/16-18 serrated flange nut as shown below.
5. Install new spring mount bracket in holes used to anchor the spring. Assemble with the supplied 3/8-16 x 3/4" bolts and 3/8-16 serrated flange nuts, inserting the bolt from inside the engine deck. Be sure the 5/16" bolt in the spring mount bracket is pointing downward.
6. Attach the new spring to the idler arm and new spring mount bracket. Install the 5/16-18 nylon lock nut on the spring mount bracket to secure spring.
7. Reinstall the rear engine deck screen.
