TOPIC: INCORRECTLY ASSEMBLED SEAT STOP ROD

AFFECTED: **1000ZKAV21/48** - serial no. 441-620
1000ZKAV23/52 - serial no. 341-430
IS3000ZKAV25/61 - serial no. 706-905

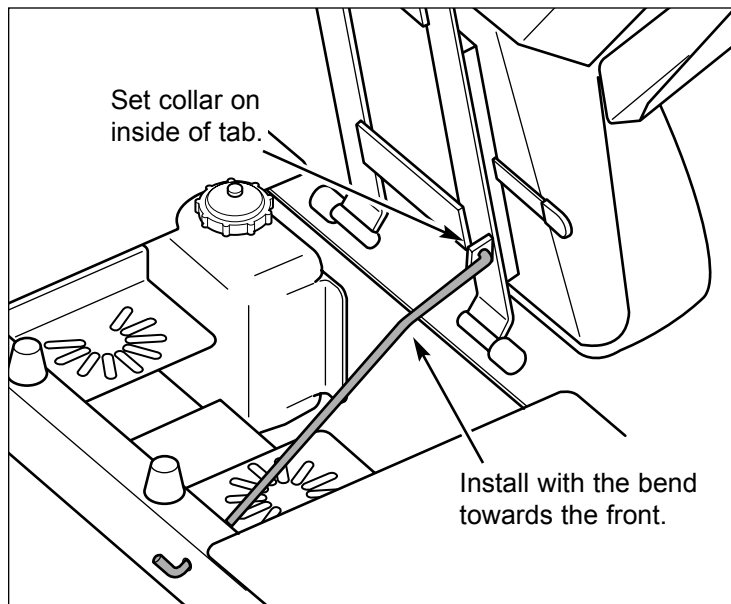
Ferris Industries has determined that the above listed models may have the seat stop rod assembled incorrectly, which may cause the rod to bind. To rectify this problem, the seat rod will need to be removed and reinstalled in the orientation shown in the illustration below.
