Ferris Industries, Inc.

Service Bulletin

F049

TOPIC: MISSING COUNTERWEIGHTS

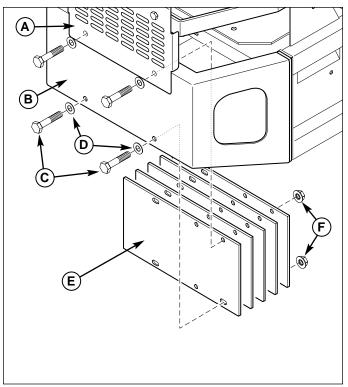
Figure 1. Install the Counterweights

Ferris Industries has determined that the above listed serial number machines were not equipped with the necessary counterweights mounted inside the rear bumper.

To rectify this, install five (5) counterweights (47485) to the rear bumper. This will provide the proper front-to-rear weight ratio for better traction and control on hilly terrain.

- 1. Remove and discard the (2) 3/8" bolts, washer & nuts that fasten the rear shield (A, Figure 1) to the bumper (B).
- 2. Install the 3/8-16 x 2-1/4" bolts (C) and 3/8" flat washers (D) through the bumper and rear shield.
- 3. Install the five counterweights (E) onto the new bolts (C) and secure with the 3/8-16 serrated flange nuts (F).
