Service Bulletin

F062

TOPIC: DIFFICULT TO PUSH (FREE-WHEEL) MOWER WITH TRANSMISSION IN NEUTRAL

AFFECTED: HC32KAV13 - S/N: 101-510

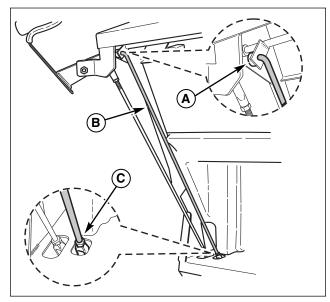
Figure 2. Brake Linkage Rod Adjustment

Ferris Industries has determined that the mower may be difficult to push with the transmission's hydraulic release rod in the neutral position. This is due to an incorrectly adjusted parking brake linkage rod.

- 1. Move the hydraulic release rod into the neutral position. (See Figure 1)
- 2. Loosen the jam nut (C, Figure 2) that secures the clevis on the lower end of the linkage rod (B).
- 3. Remove the set collar (A) that fastens the linkage rod (B) to the operator presence linkage tab.
- 4. Turn the rod 1-2 full revolutions. (Turn clockwise to shorten; counter-clockwise to lengthen)
- 5. Reinstall the rod into the linkage tab and secure with the set collar.
- 6. Grasp the operator presence / parking brake handles and the handle bar grips at the same time to disengage the parking brake.
- 7. Attempt to push the mower. If it is still difficult, repeat Step 3 5.
- 8. After making adjustment, tighten the jam nut against the clevis.
