TOPIC: FUEL HOSES ROUTED INCORRECTLY

AFFECTED: IS5000Z/C31D - S/N: 566-635

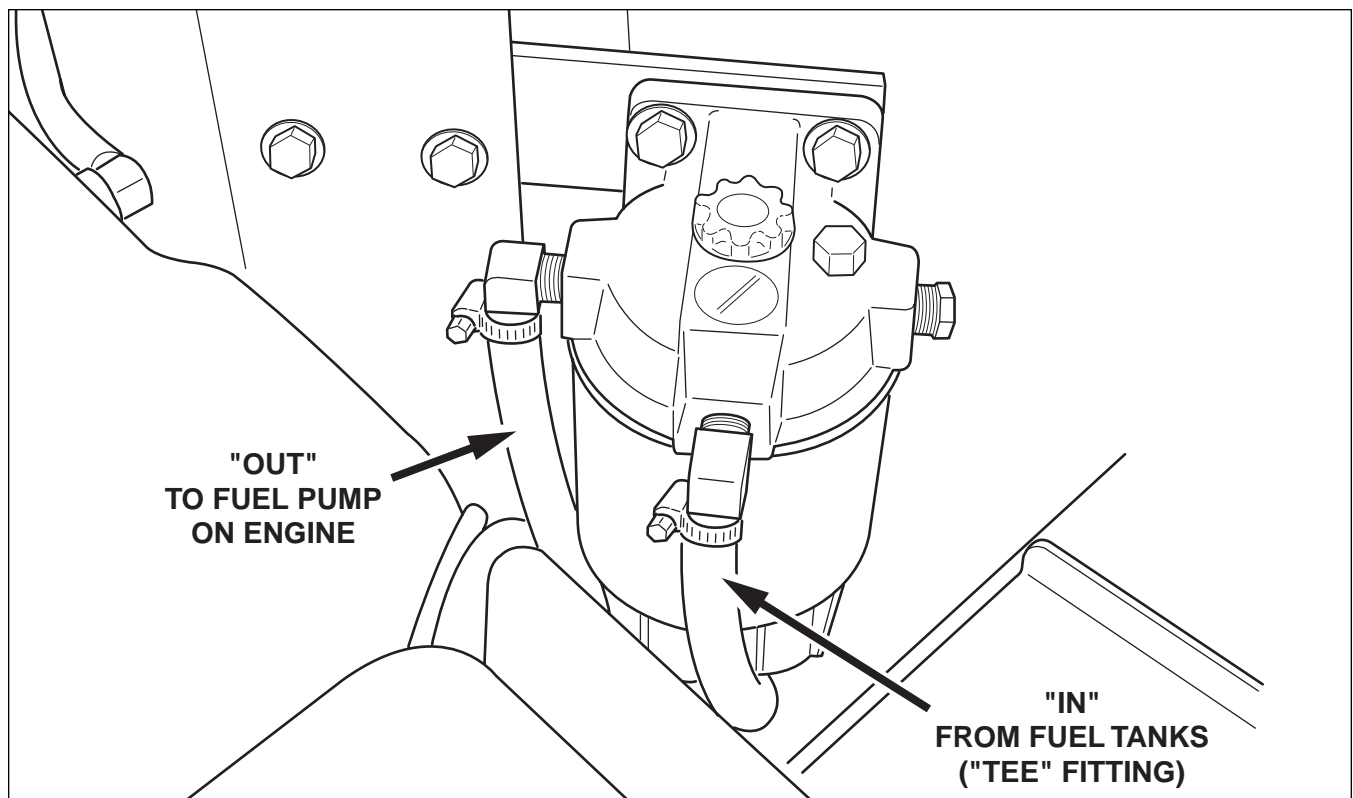
Ferris Industries has determined that the fuel hoses connected to the water separator may be installed incorrectly.

Verify the hose routing by referring to the illustration below. If the hose routing is incorrect, disconnect and reconnect the hoses in the proper locations shown.

Follow the "Priming The Fuel System" instructions in either the setup instructions or operator's manual.
