**TOPIC: PUMP DRIVE PULLEY SPACER AND
PREMATURE CLUTCH FAILURE**

AFFECTED: IS5000Z/C31D, IS5000Z/C31DCE, IS5000ZC31D61CE
serial no. 101 - 200 (Pump Pulley Spacer Kit - # 49197)
serial no. 201 - 881 (Pump Pulley Spacer / Clutch Kit - # 49319)

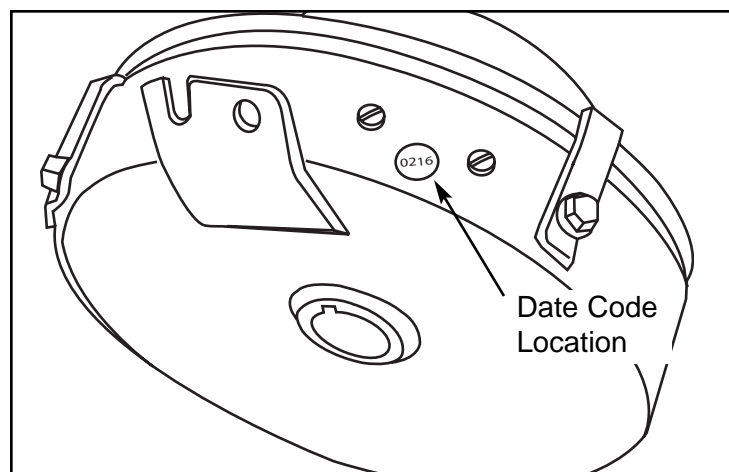
The clutch to be replaced will have a date code of 0216 thru 0341. See Illustration for approximate date code location.

To correct these problems, two kits have been created. Both kits include a new spacer and shorter key. The Pump Pulley Spacer / Clutch Kit also include a new clutch.
