March 2005

TOPIC: SLACK IN ENGINE WIRE HARNESS

AFFECTED: IS1500ZKAV1944

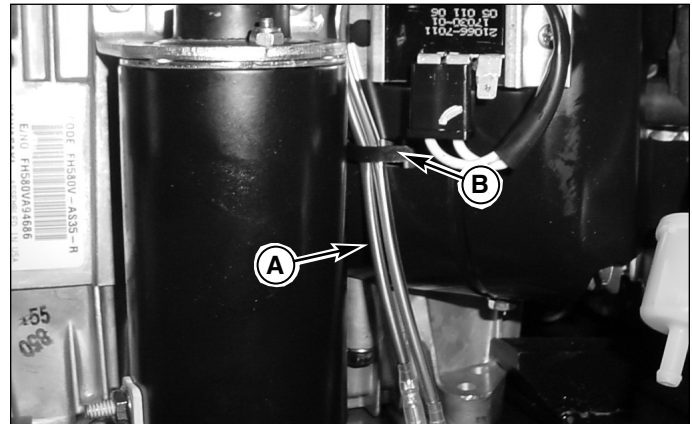
Figure 1. Engine out of chassis

Ferris Industries has determined that the engine wire harness retaining tab, on the left-hand side of the 19HP engine is not retaining the wire harness properly. If not properly retained, the potential exists for the wire harness to contact the ring gear of the engine flywheel, causing an electrical system malfunction.

1. Locate the engine wire harness (A) on the left-hand side of the machine.
2. Pull the green and black wires down to remove all slack.
3. Loosely install a small tie wrap over the green and black wires of the engine harness.
4. Slide the tie wrap up and over the harness retaining tab (B).
5. Tighten the tie wrap and trim excess.
6. Firmly press the harness retaining tab inward to insure that all slack in the harness has been removed.
