Possible Oil Reservoir Cap Leak

All IS1500Z Models

101-948

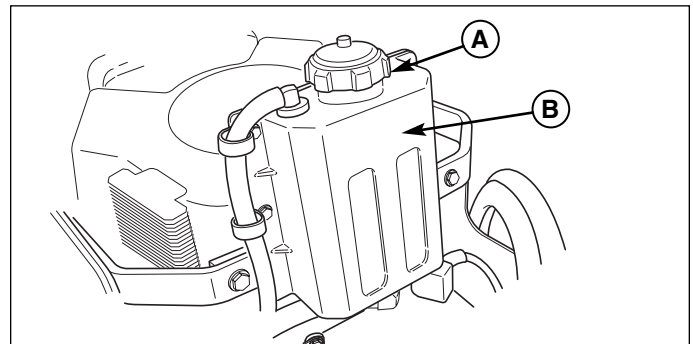
**Figure 1. Oil Reservoir**

Early production IS1500Z Series zero-turn riders were built with oil reservoir caps that may leak. New caps (part number 5100017) are available, and will be shipped to you automatically, **at no charge**.

Only units in the listed serial number range are affected by this update due to an interference between the reservoir and the original cap. Product above the serial number range has had the interference corrected.

Please replace the caps on all units in your inventory and all retailed units that fall within the serial number range.
