Possible Contact Between Gearbox and Engine Oil Pan Causing Leak

Models:
IS5000Z/C31D, 31HP diesel, zero-turn riding mower

Serial Numbers:
1220-1480

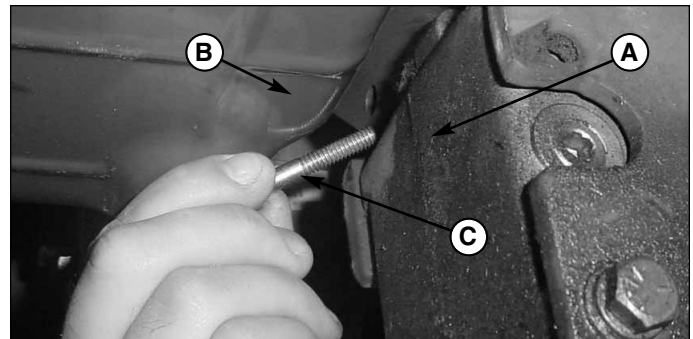
Field reports indicate the deck drive gearbox has the potential to come into contact with the engine oil pan, causing damage to the oil pan that may cause a leak.

Figure 1. Check Gearbox & Oil Pan Clearance

1. Park the machine on a flat, level surface and engage the parking brake. Disengage the PTO switch, turn off the engine and remove the key from the ignition.
2. Check the clearance between the gearbox and the engine oil pan (see Figure 1).
3. If you can pass a 1/4" bolt between the gearbox and oil pan, no further action is required. If you **cannot** pass a 1/4" bolt between the gearbox and oil pan, order and install Gearbox Shim Kit (5600028).
