IS3000ZL26/61 POSSIBLE MISSING HARDWARE ON CRANKSHAFT BOLT.

IS3000ZL26/61

Work Performed: Repaired per Service Bulletin F086

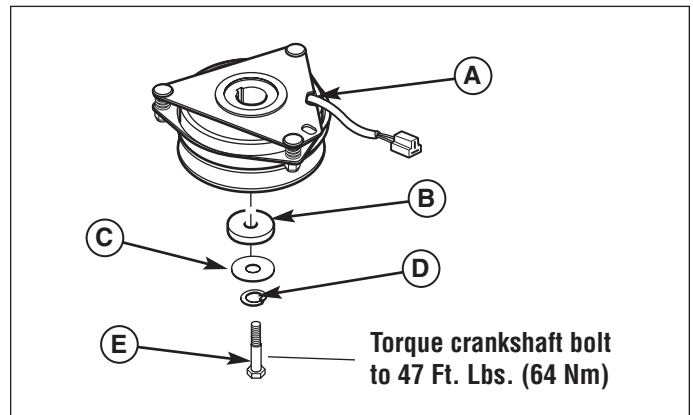
Figure 1. Correct Assembly of Crankshaft Hardware

Ferris has determined that a lock washer and a flat washer may have been left off the crankshaft bolt during assembly.

1. Inspect the crankshaft bolt (E, Figure 1) for washers (C, D) as shown in illustration, if present no further action is required. If washers are not found, order and install lock and flat washer on the crankshaft bolt and torque to 47 ft/lbs.
