F087
SERVICE BULLETIN

DECEMBER 06

INCORRECT CRANKSHAFT SPACER USED ON 27HP KOHLER IS2000Z MODELS

MODELS AFFECTED			
Brands	Model Nos.:	Serial No. Range:	Description:
Ferris	5901170 5900625	2000666746 & below.	IS2000Z, 27 HP Zero-Turn Riding Mower w/52" & 61" mower deck.

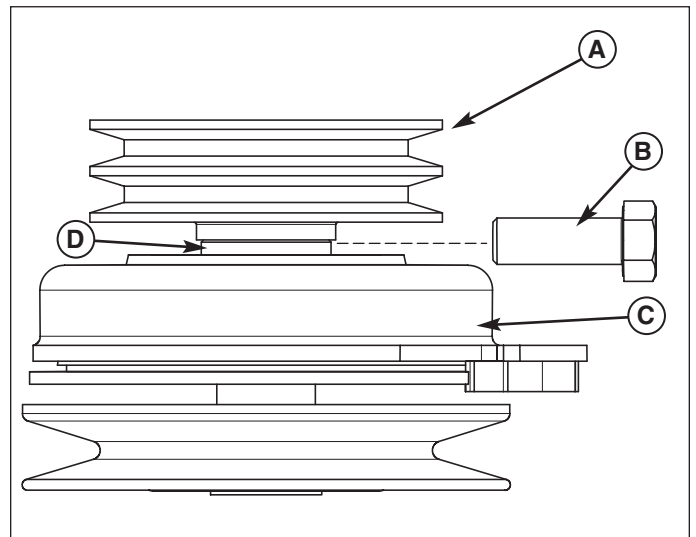
Field reports indicate that an incorrect length spacer is causing engine crankshaft failures on some units in the field that are within the serial number range listed above.

1. Park the machine on a flat, level surface and engage the parking brake. Disengage the PTO switch, turn off the engine and remove the key from the ignition.
2. To evaluate whether the unit is affected, place a 5/8" bolt (B, Figure 1), (P/N #5025320X14 which is a 5/8-11 X 1-3/4" bolt, will work in this instance) between the crankshaft pulley (A) and the PTO clutch (C). If the shaft of the bolt slides in and makes contact with the spacer, the unit is not affected and no further action is required. If the shaft of the bolt does not slide in and make contact with the spacer, continue with the following corrective procedure.

Figure 1. Inspecting the Machine
A. Crankshaft Pulley
B. 5/8" Bolt
C. PTO Clutch
D. Crankshaft Spacer

1. Order and install Service Kit # 5600094.
