**F099**

SERVICE BULLETIN

**JULY 2008**

**New Hardened Washer Available to Prevent Over-Tightening of Blade Mounting Bolt While Unit is in Use**

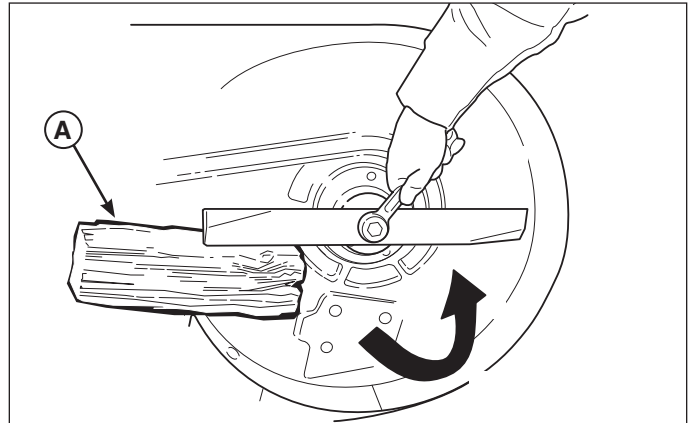
**Figure 1. Remove the Blade Mounting Bolt  
A. Wooden Block**

Field reports indicate that units within the serial number range listed above could potentially have a material issue with the blade washer that could cause extreme over-tightening of the blade mounting bolts used to secure the mower blades to the unit.

1. If your unit falls within the serial number range listed above, order a quantity of two (2) 5025477 - "Washer, 5/8" Grade 8" (HydroCut models), or three (3) 5025477 - "Washer, 5/8" Grade 8" (all other models).
2. Park the machine on a flat, level surface. Disengage the PTO, engage the parking brake, stop the engine and remove the key from the ignition.
3. Wedge a wooden block (A, Figure 1) between the mower blade and the mower deck housing to prevent the blade from turning.
