## Procedure for Repositioning IS5100Z Hydro Drive Spring

## Product Information Notice # 70

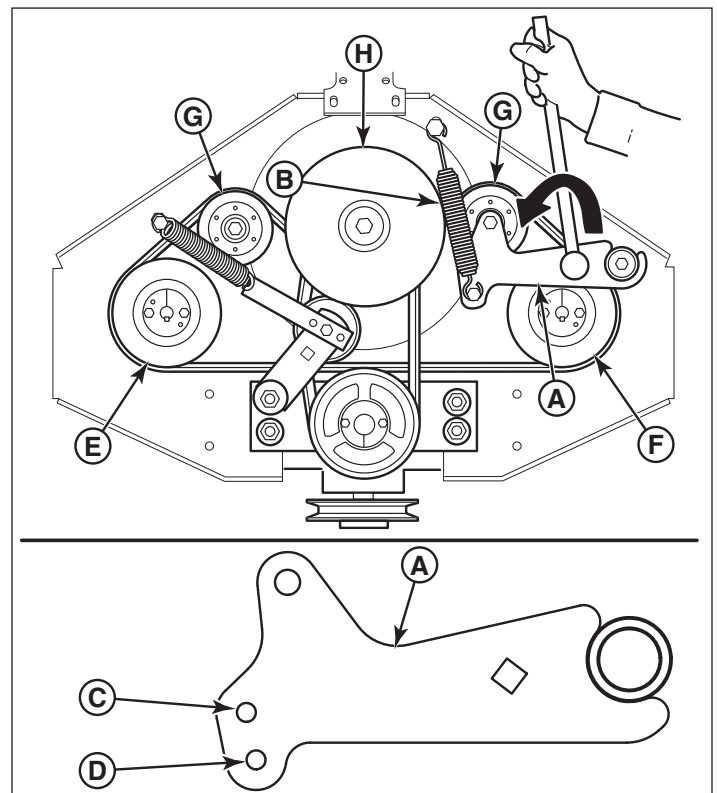
Figure 1. Inspecting the Idler Arm

1. Park the zero-turn rider on a smooth, level surface such as a concrete floor. Disengage the PTO, engage the parking brake, turn the ignition switch to OFF, and remove the ignition key.
2. Release the hood latch, raise the hood, and secure in the open position.
3. Remove the rear belt shield.
4. Observe the hydro drive idler arm (**A, Figure 1**) and tensioning spring (**B**).
5. There are two spring mounting holes in the hydro drive idler arm:
  - If the spring is installed in the **upper hole (C)** of the hydro drive idler arm, the spring is **not installed correctly**, perform the *Correction* procedure.
  - If the spring is installed in the **lower hole (D)** of the hydro drive idler arm, the spring is **installed correctly** continue with step #6.
6. Re-install the rear belt shield and lower the hood. Make sure the hood is firmly latched.

1. Using a 1/2" breaker bar, place the square end in the square hole located in the idler arm (**A, Figure 1**). Carefully rotate the breaker **counter-clockwise** which will relieve the tension on the belts exerted from the idler arm.
