TOPIC: PROPER BRUSH CUTTER CHAIN CURTAIN ASSEMBLY AND INSTALLATION

**AFFECTED: BC25BE
BC25H**

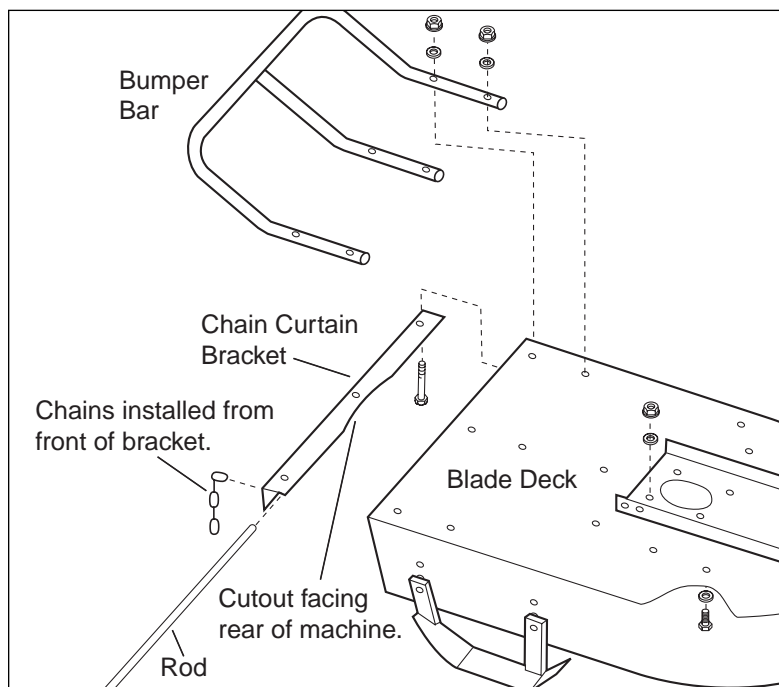
Quality audits indicate that the Chain Curtain Bracket may be installed incorrectly which may allow contact between Cutting Blade and Chain Curtain.

When assembling units, verify that the Chain Curtain Bracket is installed with the cutout facing the rear of the machine and the chains are installed from the front of the bracket.

Improper assembly and/or installation of Brush Cutter Chain Curtain may contact between Cutting Blade and Chain Curtain and may result in severe injury or equipment damage.
