**DATE:** FEBRUARY 2013**TO:** ALL AUTHORIZED FERRIS DEALERS**SUBJECT:** RECOMMENDED DRIVE TENSIONING SPRING UPDATE ON FERRIS IS600Z & IS700Z UNITS**MODELS:** SEE LIST BELOW

DESCRIPTION

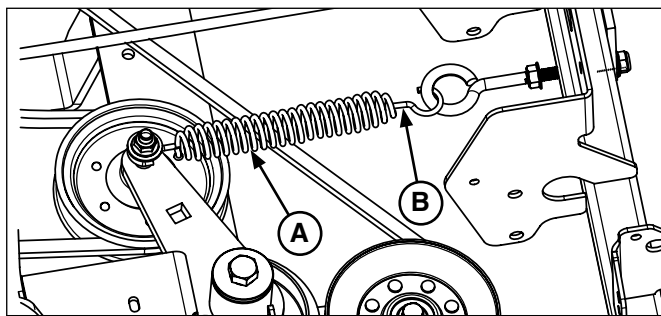
1. Raise the seat plate to gain access to the drive tensioning spring.
2. Visually examine the spring.
 - If the spring (**A**, **Figure 1**) has a short forward hook (**B**) proceed to **Correction Procedure**;
 - If the spring (**A**, **Figure 2**) has a long forward hook (**B**), no action is necessary.

Figure 1. Old Style Drive Tensioning Spring (Replace)

1. Order and install kit # 5600670.

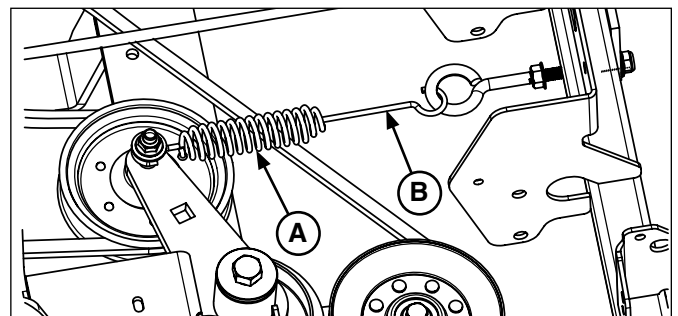
Figure 2. New Style Drive Tensioning Spring (No Action Required)
